BELZONA SUPERWRAP II RESTORES PIPE AT DAM WALL

ID: 5572

Customer Location: National Water Company, Wales, UK
Application Date: March 2015

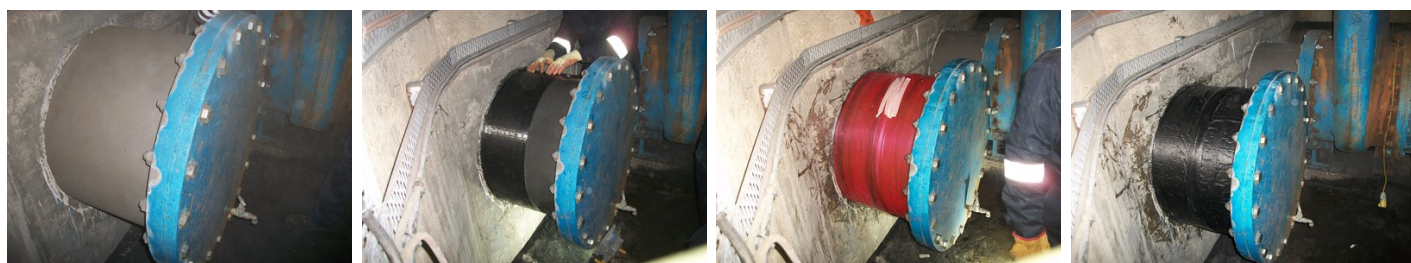
Photograph Descriptions

The pipe had suffered from corrosion over time which had caused the formation of pits on the surface of the steel. This resulted in weakening of the pipe wall and requirement to repair the steel. As the pipe cannot be shut off, an in-situ, cold applied repair was chosen.

- * Pipe condition following grit blasting ,
- * Initial wrap commencing ,
- * Following complete system application, Belzona 9382 release film is applied ,
- * Completed application with release film removed ,

The application was carried out as per the Belzona Superwrap II method statement provided. Following thorough grit blasting to the required standard, the Belzona Superwrap II system was applied. Once the required thickness and number of wraps were achieved, the repair was consolidated in Belzona 9382 Release Film and allowed to cure. Once cured the Belzona 9382 release Film was removed.

Application of the Belzona Superwrap II system to this pipe provides a long term repair solution which will restore strength as well as avoiding further external corrosion to the pipe.
