# INTERNAL PIPE LINING TRIAL WITH BELZONA

ID: 5605

Customer Location: Oil Company, Qatar  
Application Date: April 2015

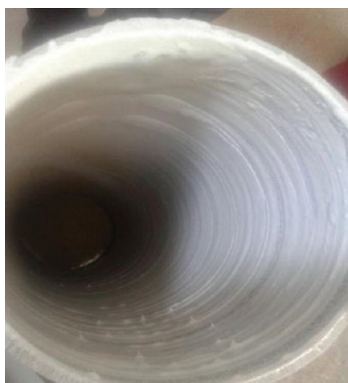
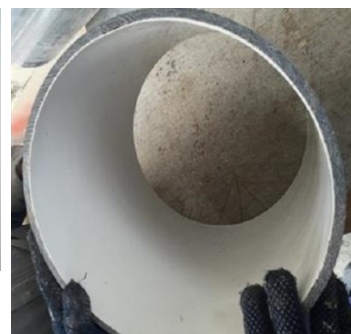
- \* Trial of alternative material ,
- \* Belzona Spin spray set up ,
- \* Spin spray in action ,
- \* After cure a cross section cut out for inspection ,

Trial application lining small diameter pipe using spin spray equipment.

After centering the spray head in the pipe the spin speed and feed rate were adjusted to obtain correct coating thickness. The calculations required are based on spin speed (rpm) feed rate and product output from the airless spray pump. After satisfactory trials the application itself will be carried out in accordance with Belzona Know-How System Leaflet VPF-2.
