INTERNAL PIPE LINING TRIAL WITH BELZONA

ID: 5605

Industry: Oil & Gas
Application: VPF-Valves, Pipes and Fittings
Substrate: PVC
Products: * Belzona 1331 ,

Customer Location: Oil Company, Qatar
Application Date: April 2015

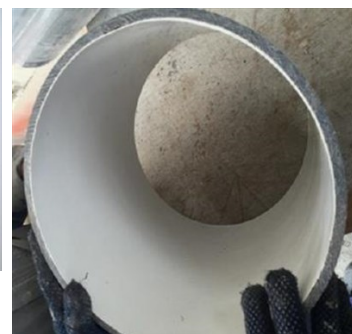
Photograph Descriptions

- * Trial of alternative material ,
- * Belzona Spin spray set up ,
- * Spin spray in action ,
- * After cure a cross section cut out for inspection ,

Trial application lining small diameter pipe using spin spray equipment.

After centering the spray head in the pipe the spin speed and feed rate were adjusted to obtain correct coating thickness. The calculations required are based on spin speed (rpm) feed rate and product output from the airless spray pump. After satisfactory trials the application itself will be carried out in accordance with Belzona Know-How System Leaflet VPF-2.
