BELZONA REPAIRS WIRE DRAWING MACHINE

ID: 5637

Customer Location: Copper Wire Industry, Northeastern USA
Application Date: 2011, 2012, 2013

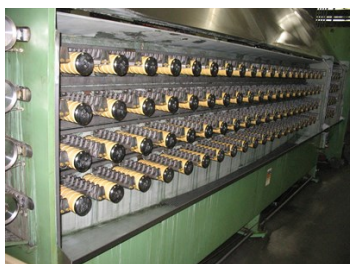
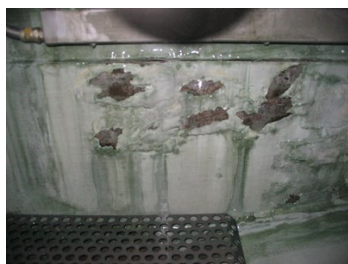
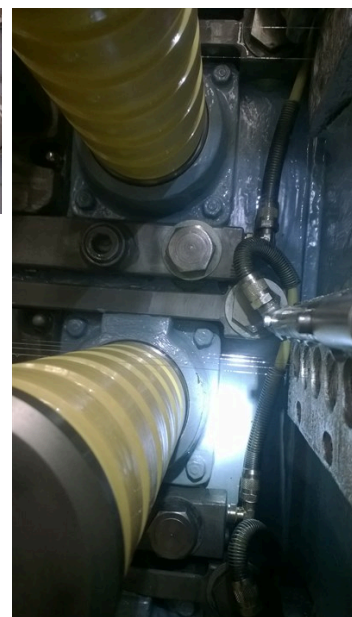
Photograph Descriptions

Corrosion cells in the drawing machine interfere with proper gaging and wire conductivity which can ruin an entire run of a speciality cable, in addition, affect plant production and cause quality problems with the finished product.

- * Overview of the wire drawing machine ,
- * Corrosion cells in the sump of the drawing machine ,
- * Blast cleaned surface before coating ,
- * Close up of coated surface after 2 years of operation, still perfect! ,

The substrate was cleaned by blasting to a near white finish standard SSPC-10. After surface preparation, Belzona 1341 was properly hand applied in accordance with the relevant IFU.
