BELZONA HIGH TEMPERATURE LINING FOR NEW AUTOCLAVE

ID: 5641

Customer Location: Vessel Fabricator, Flums, Switzerland
Application Date: October, 2014

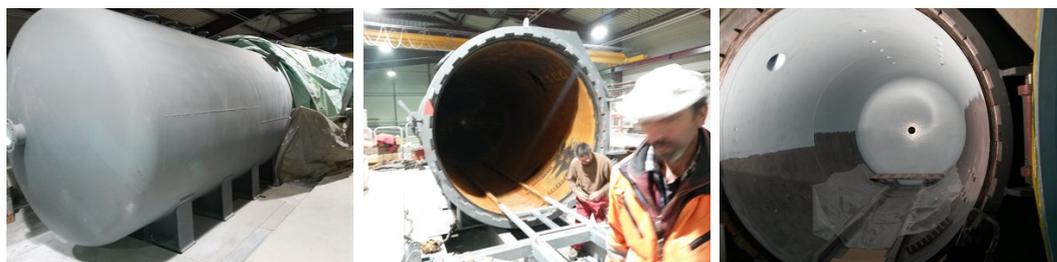
Photograph Descriptions

- * Outside view of autoclave ,
- * Autoclave ready for grit blasting ,
- * Lining application in action ,

The application was carried out in accordance with Belzona Know-How System Leaflet TCC-5. After grit blasting to SA 2.5 a two-coat system of Belzona 1593 was hand applied to an area of 45m² (484 ft²).
