# BELZONA IMPROVES EFFICIENCY OF A FIRE TRUCK

ID: 5662

Industry: *Transport*  
 Application: *CEP-Centrifugal Pumps*  
 Substrate: *Cast iron*  
 Products: *\* Belzona 1311 (Ceramic R-Metal),*  
*\* Belzona 1341 (Supermetalglide),*

Customer Location: *Northeastern Washington, USA*  
 Application Date: *July 2015*

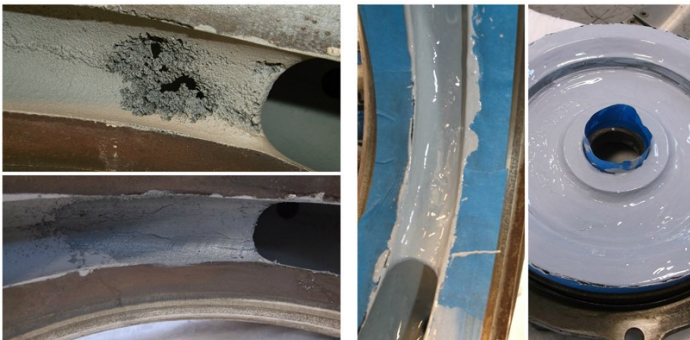
*Cavitation on the cut-water in the pump.*

- \* Cavitation damage / Repaired cavitation damage ,
- \* Coated cut-water / Coated end plate ,
- \* Pre testing from the first pump showing 1750 rpm ,
- \* Post testing from the first pump showing 1600 rpm ,

The application was carried out in accordance with Belzona Know-How System Leaflets CEP-1 and CEP-3. The surface was grit blasted for preparation and Belzona 1311 applied to repair the cavitation damage, then Belzona 1341 was applied for protection and improved efficiency.

of material. This is the second pump this fire department has repaired and coated. These pumps pump 1000 gpm. Prior to coating the pump ran at 1750 rpm to pump 1000 gpm. After coating, the pump only runs at 1600 rpm to pump 1000 gpm.
