BELZONA PROTECTS OIL PIPE LINES

ID: 570

Customer Location: Oil production company, Egypt
Application Date: December 2003

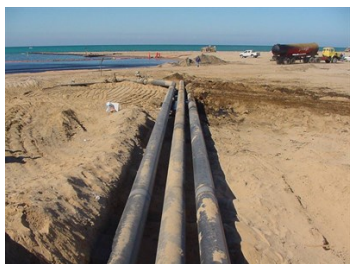
- * Crude oil pipe lines ,
- * Welding seams of the pipe lines ,
- * Applying Belzona® 5891 ,
- * Application carried out on all welding seams of the pipe line ,

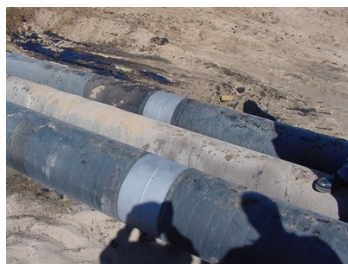
Pipe line welding seams were weak due to welding and need to be protected from corrosion that will be accelerated due to salts in air from the sea and high temperature. Belzona provides this protection.
