# BOSCH CHAINLESS DIFFUSER COATED WITH BELZONA

ID: 5703

Customer Location: Sugar Mill, Illovo Ubombo, Swaziland  
Application Date: 2010

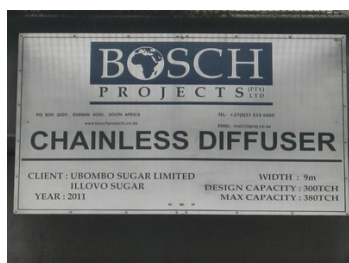
- \* Chainless Diffuser designed by Bosch & Associates ,
- \* General view of the sugar plant ,
- \* Structural Steelwork coated with Belzona 5891 ,
- \* Steam inlet pipes coated with Belzona 1391 ,

A brand new Chainless Diffuser designed by Bosch & Associates was built on site at Illovo Ubombo in Swaziland. The entire internal structural steel work and piping required an erosion and corrosion resistant coating applied to the new steel prior to assembly.

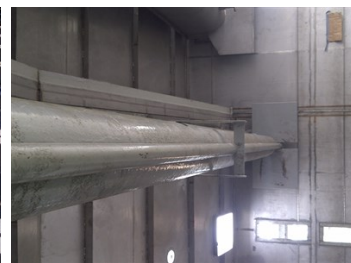
The problem with raw sugar cane as it gets processed in the diffuser is three fold: 1) abrasion from the raw crushed cane fibres, 2) there are traces up to 5% Acetic Acid in the raw cane juice, and 3) the dry heat temperature on the steam inlet pipes is 130°C and the wet temperature inside the diffuser is 95°C.

The application was carried out in accordance with Belzona Know-How System Leaflet TCC-5. All areas were prepared by grit blasting with platinum slag. All detail work such as welds were stripe coated. Belzona 5891 applied at 600 micron was selected for all of the channel iron structural steel, approximately 2700 m<sup>2</sup> in total. Belzona 1391 was applied to the spiral feeds and all steam inlet pipes, approximately 500 m<sup>2</sup>, at 900-1000 micron thickness.
