CREATING CUTLASS BEARINGS WITH BELZONA

ID: 577

Application: CEP-Centrifugal Pumps

Water lubricated cutlass bearings from sea water lift pumps

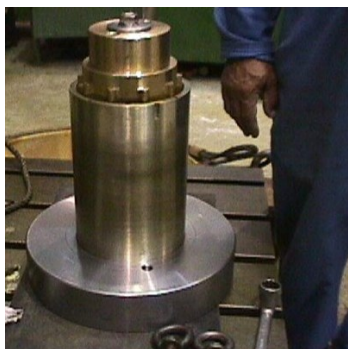
Original bearings were being worn out rapidly by the high sand content in the water.

- * Accurate mold created to form the bearings ,
- * Belzona Elastomer being poured into the mold ,
- * Completed bearing ,

Application was carried out in accordance with Belzona Know-How System Leaflet CEP-9.

Over 300 bearings have been cast. Reclaiming the original sleeve allows new bearings to be produced at a fraction the cost of new ones. In addition the life of the Belzona cast bearings was found to be longer than the originals.
