BELZONA REFURBISHES ALL VALVES DURING F.S.O. REFURBISHMENT

ID: 579

Application: VPF-Valves, Pipes and Fittings

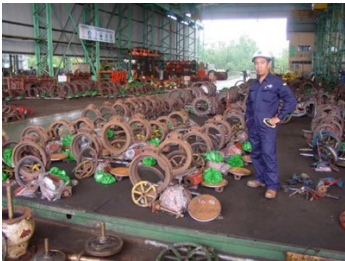
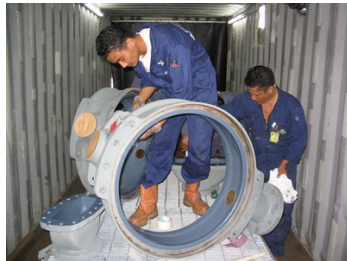
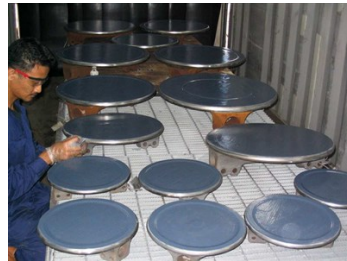
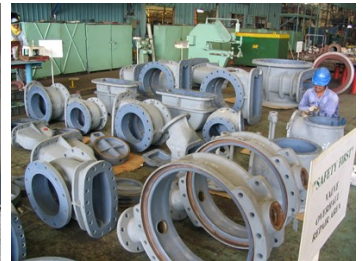
Photograph Descriptions

More than 200 valves including butterfly, globe and gate types in many sizes required refurbishment and corrosion protection during the refurbishment of the FSO.

* Some of the many valves to be refurbished Application to valve bodies underway Some of the many valve discs protected Completed gate and butterfly valve bodies ,

Application was carried in accordance with Belzona Know-How System Leaflets VPF-1 & VPF-2.

Belzona coating will protect the valves during future service exposed to sea water and crude oil as produced from the offshore oil field.
