# BELZONA REFURBISHES ALL VALVES DURING F.S.O. REFURBISHMENT

Application: VPF-Valves, Pipes and Fittings

Application Date: March 2004

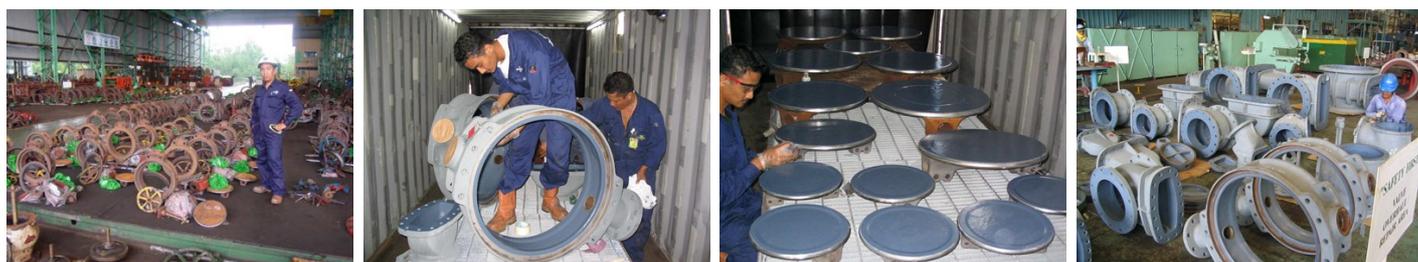
## Photograph Descriptions

\* Some of the many valves to be refurbished Application to valve bodies underway Some of the many valve discs protected Completed gate and butterfly valve bodies ,

More than 200 valves including butterfly, globe and gate types in many sizes required refurbishment and corrosion protection during the refurbishment of the FSO.

Application was carried in accordance with Belzona Know-How System Leaflets VPF-1 & VPF-2.

Belzona coating will protect the valves during future service exposed to sea water and crude oil as produced from the offshore oil field.
