BELZONA ANTI-CAVITATION SYSTEM PROTECTS NAVAL VESSEL

ID: 5795

Industry: *Marine*
Application: *SOS-Ships and Offshore Structures*

Customer Location: *US Navy Base, Japan*
Application Date: *2012*

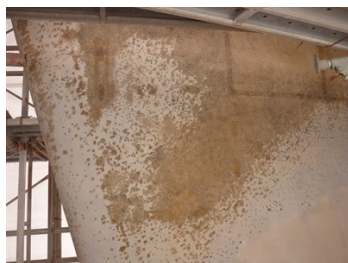
Due to the shape of the rudders, coupled with disturbed water flowing from the propeller, and the high manoeuvrability of the vessel, cavitation damage occurs leading to severe erosion corrosion pitting.

- * Overview of the rudders ,
- * Close-up view of a damaged area ,
- * Belzona 1341 applied as the first coat ,
- * Application completed with a coating of Belzona 2141 ,

The application was carried out in accordance with Belzona Know-How System Leaflets SOS-1 & SOS-2. Rebuilding of the pitted areas was carried out using Belzona 1311. Belzona 1341 was used as the first coat to provide optimum adhesion and corrosion resistance. The Belzona 2141 system was applied as the top coating to provide cavitation resistance.
