# BELZONA ANTI-CAVITATION SYSTEM PROTECTS NAVAL VESSEL

ID: 5795

Naval vessel rudders.

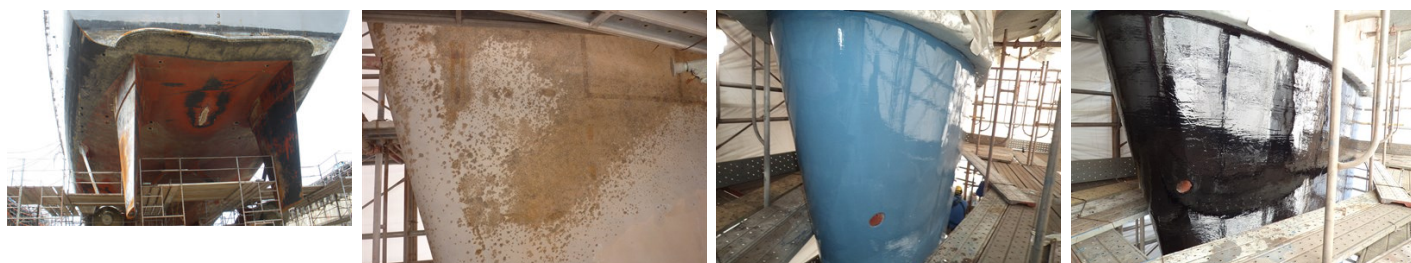
*Due to the shape of the rudders, coupled with disturbed water flowing from the propeller, and the high manoeuvrability of the vessel, cavitation damage occurs leading to severe erosion corrosion pitting.*

- \* Overview of the rudders ,
- \* Close-up view of a damaged area ,
- \* Belzona 1341 applied as the first coat ,
- \* Application completed with a coating of Belzona 2141 ,

The application was carried out in accordance with Belzona Know-How System Leaflets SOS-1 & SOS-2. Rebuilding of the pitted areas was carried out using Belzona 1311. Belzona 1341 was used as the first coat to provide optimum adhesion and corrosion resistance. The Belzona 2141 system was applied as the top coating to provide cavitation resistance.

protection. The Belzona application was inspected after 2 years and was mostly found to be in perfect condition with only minor damage in the local areas. The coating had overcome the major cavitation and erosion problems and was easily repaired with minimal downtime. The client was satisfied with the Belzona solution.
