BELZONA REPAIRS AND PROTECTS CONCRETE AROUND HANDRAIL POSTS

ID: 5813

Customer Location: Stratfordville, ON, Canada
Application Date: June 2015

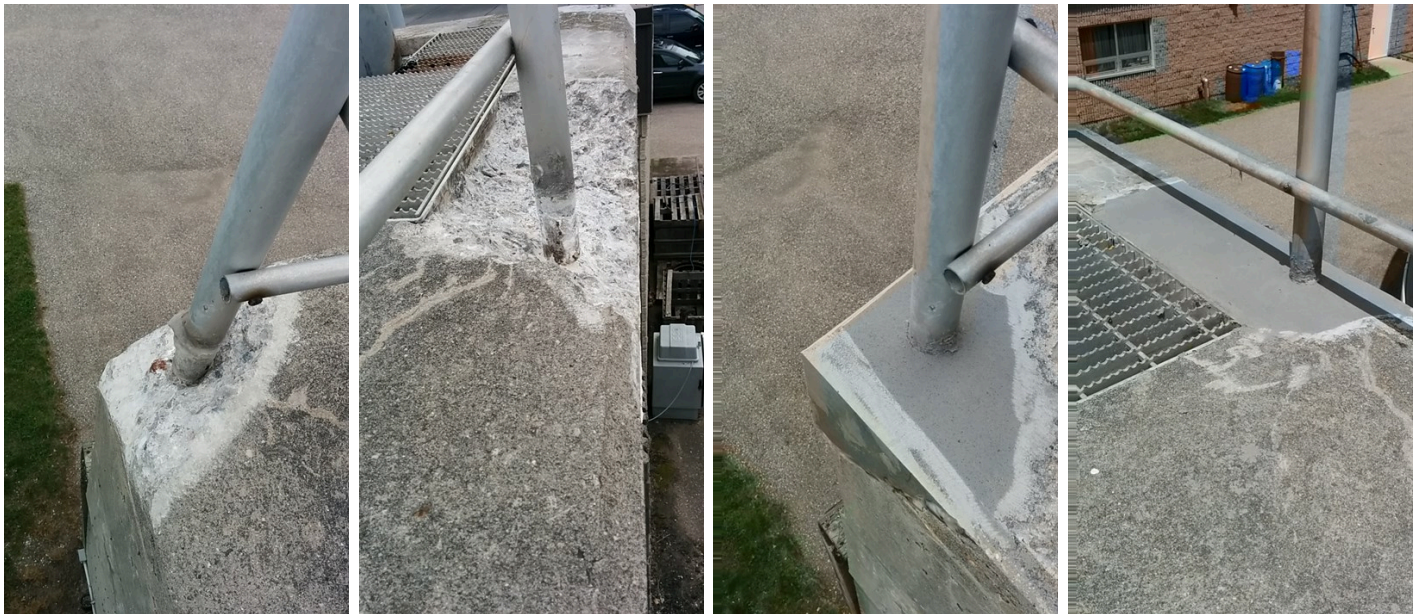
Photograph Descriptions

The concrete around the handrail posts was badly spalled. Some of the damage was from a combination of environmental (freeze thaw effect) and proximity of the concrete to the clarifier tanks.

- * Top view of damaged concrete ,
- * Side view prior to application ,
- * Top view of completed application ,
- * Completed application ,

The application was carried out in accordance with Belzona Know-How System Leaflet FPA-10 for fixing or securing anchor bolts or handrails. A grinder was used to prepare the surface and any loose concrete was removed. Belzona 4911 was applied to the prepared surface using a stiff bristle brush. Belzona 4131 was applied in accordance with Belzona Instructions For Use.
