BELZONA FILLS PITTED AREAS AND COATS 54 INCH JET VALVE

ID: 5820

Pitted areas of a 54 inch jet valve need to be filled and coated

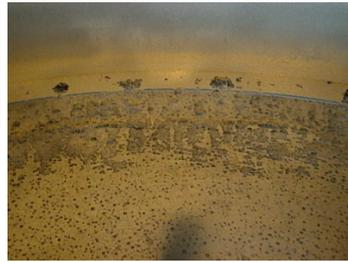
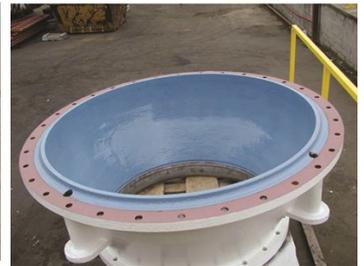
- * View of pitted shell ,
- * Pitting filled with Belzona 1111 ,
- * View of valve prior to application ,
- * Completed application with Belzona 1341 ,

The surface was prepared by blast cleaning to meet the minimum requirement of SA 2 1/2 or equivalent in accordance with ISO 8501-1. All edges or irregular protrusions were ground to a smooth contour and all dust, blast media and other debris were removed. All surfaces were degreased using a suitable cleaner-degreaser. The mixed Belzona 1111 was scrubbed into the pit in order to wet it out completely. Once wetted out, additional Belzona 1111 was applied to fill the pit and not just bridge . over it. An applicator was used to contour Belzona 1111 to the shape of the vessel. Once cured, Belzona 1341 was applied at a thickness of 250-300 microns. The surface preparation for the valve was carried out as it was for the pitted areas. Belzona 1341 was then applied as a stripe coat and overcoated within the 24 hours overcoating window. The applied material was visually checked for pinholes to ensure proper application.
