OFFSHORE PRODUCTION DECK RESTORATION WITH BELZONA

ID: 5829

Industry: Oil & Gas
Application: SOS-Ships and Offshore Structures

Total restoration of production platform deck using Belzona Cold Plate bonding system.

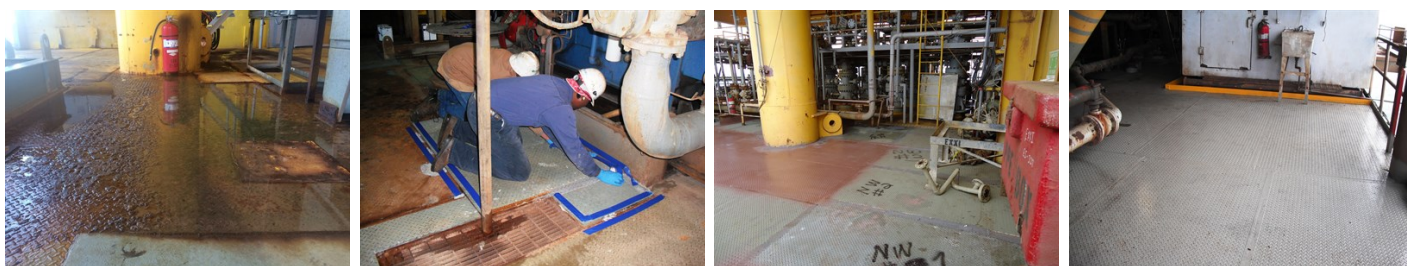
Photograph Descriptions

Years of service without adequate maintenance in the offshore environment caused severe corrosion/metal loss of the production deck, impacting the structural integrity and personnel safety.

- * Condition of deck before restoration. ,
- * Installation of plate bonding system. ,
- * Restoration of new plates complete. ,
- * Two coat system of Belzona 5811 applied to new deck plates. ,

The deck area to be restored was cleaned and prepared by UHP/aggregate/rust inhibitors. Belzona 9111 was used as a wipe down to clean and degrease all areas. The Belzona Cold Plate Bonding System was installed using Belzona 1121 as adhesive. A two coat system of Belzona 5811/Aggregate was installed afterwards. The aggregate was used to create an antislip surface.
