# BELZONA PROTECTS DOOR TO DIGESTER AGAINST CORROSION

ID: 5838

Customer Location: Niagara Region, ON, Canada  
Application Date: December 2014

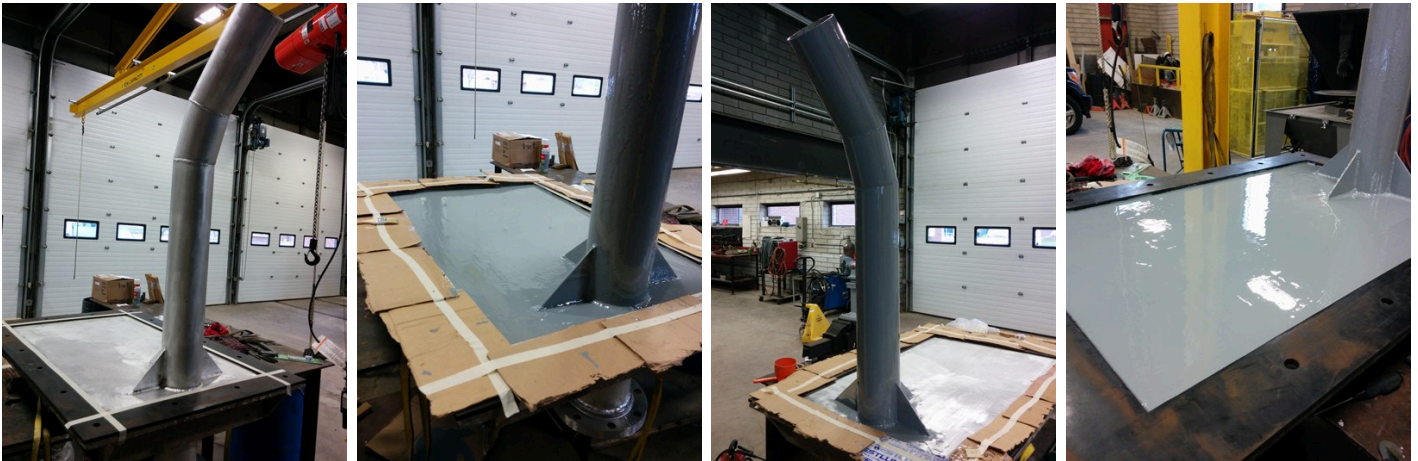
The previous door was suffering from corrosion. The customer wanted long-term protection on the new door prior to installation.

- \* Prior to application ,
- \* Application in progress ,
- \* Application in progress ,
- \* Completed application ,

The application was carried out in accordance with Belzona Know-How System Leaflet VPF-2 for applying erosion-corrosion resistant coatings. A grit blaster was used to prepare the surface. Belzona 5811 was applied as a two coat system using a short bristle brush in accordance with the Belzona Instructions For Use.
