# BELZONA PROTECTS PUMP FOUNDATIONS

ID: 584

Industry: *Power*  
Application: *TCC-Tanks and Chemical Containment Areas*  
Substrate: *Concrete*  
Products: *Belzona® 4311 (Magma CR1)*

Customer Location: *Power Industry, Bulgaria*  
Application Date: *July 2002*

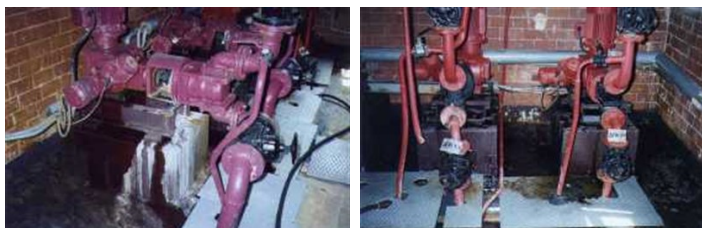
*Leaks from the pumps destroy their unprotected concrete foundations.*

\* Before coating applied , \* 1½ years after application ,

Dosing and mixing pumps in water treatment plant.

The application procedure was carried out in accordance with Belzona Know-How System Leaflet TCC-15.

Belzona® 4311 provides complete protection from the chemicals used in the water treatment process. There is no damage after 1½ years service.
