# BELZONA PROVES TO BE THE RIGHT CHOICE FOR FLANGE PROTECTION

Industry: Oil & Gas  
Application: GSS-Gaskets, Seals and Shims  
Substrate: Carbon Steel  
Products: \* Belzona 3411 (Encapsulating Membrane),  
\* Belzona 8411,

Customer Location: Texas, USA  
Application Date: December 2014

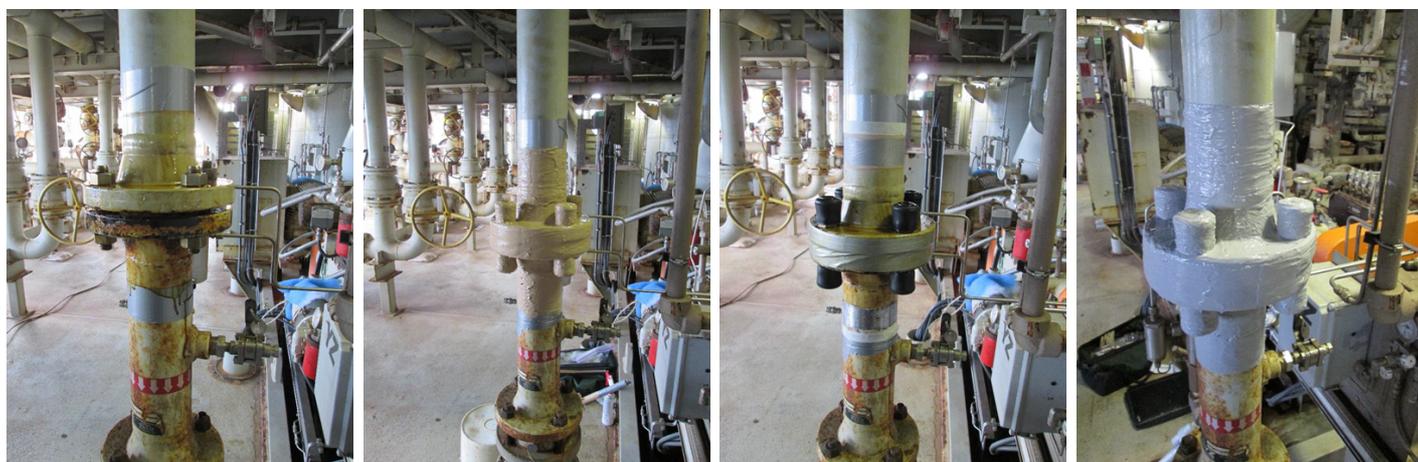
Corrosion around the flanges and bolts resulted in serious damage. The customer was looking for a practical and efficient solution to this problem. Several manufacturers were considered for the task including Belzona. Application was to be completed in situ and inspected after 6 months.

- \* After surface preparation, Belzona 8411 was applied to the flange ,
- \* Substrate ready for application with bolt covers and bridging tape ,
- \* Application of base coat of Belzona 3411 ,
- \* Application completed with second coat of Belzona 3411 ,

The application was carried out in accordance with Belzona Know-How System Leaflet GSS-11.

The customer chose Belzona since a competitor's solution 'oozed' out some sort of embedded corrosion inhibitor that looked like leaking oil. After a 6 month trial inspection, the Belzona coating was removed and the underlying flange was visually evaluated. The Customer was pleased with the results and decided to install the Belzona 3411 system on other facilities.
