BELZONA OFFERS PROTECTION TO NEW FLOATING HEAD

Industry: Oil & Gas
Application: HEX-Heat Exchangers
Substrate: Steel
Products: * Belzona 1321 (Ceramic S-Metal) ,

Customer Location: Toronto, ON, Canada
Application Date: April 2015

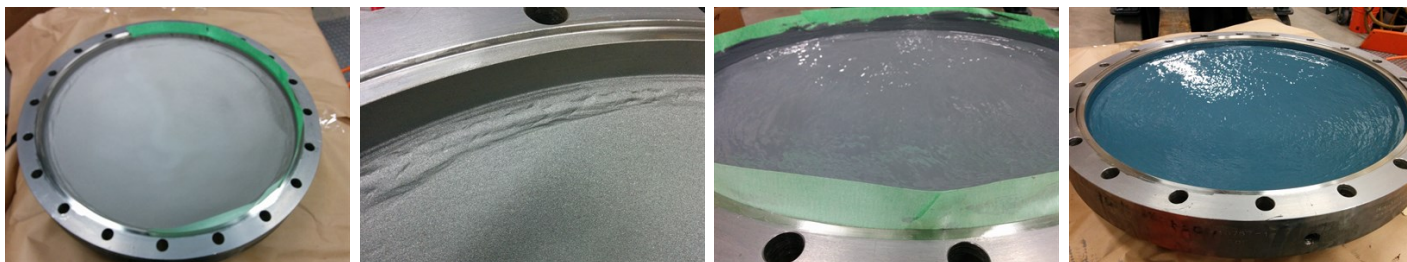
Photograph Descriptions

Deterioration of the surface due to erosion/corrosion by in-service conditions.

- * Surfaces abrasive blasted being masked prior to coating ,
- * Close up of abrasive blasted profile ,
- * Application of 1st coat of Belzona 1321 (Grey) ,
- * Completed application 2nd coat of Belzona 1321 (Blue) ,

The application was carried out in accordance with Belzona Know-How System Leaflet HEX-3 for erosion/corrosion resistance coatings. Masking tape was placed at the outer edge of the rebate grooves in order to highlight the area to be coated and to give a neat and clean finish. Then, the selected Belzona product was mixed and an even coat was applied at the specified thickness, using stiff short bristled brushes. Then, it was made sure that the coating was finished into the rebate grooves. Wet film thickness gauges were used to ensure the recommended film thickness was achieved. The masking tape was removed immediately. Allow to cure before applying a second coat, where specified, of the selected Belzona product, again ensuring that it is correctly finished within the rebate grooves.
