# BELZONA 7111 PROVIDES CHOCKING TO DRIVE SYSTEM ON FISHING BOAT

Industry: Marine

Customer Location: Fishing Company, Peru

Application: GSS-Gaskets, Seals and Shims

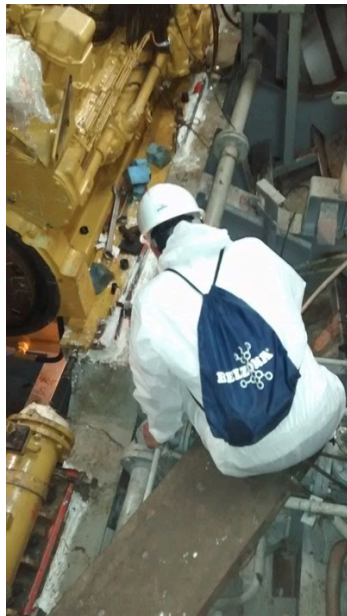
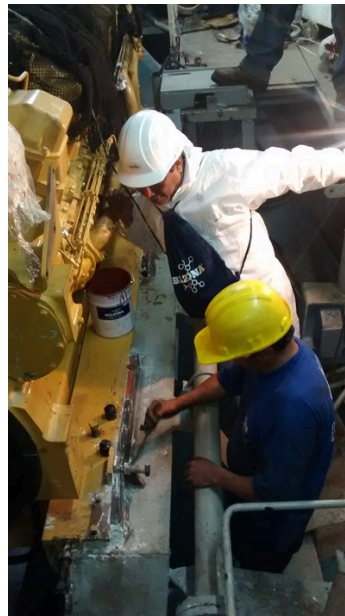
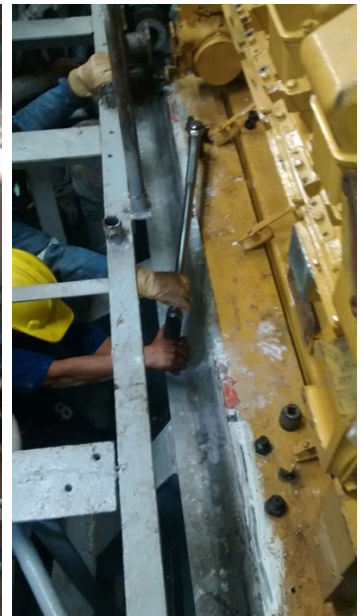
- \* View of the engine and machine room ,
- \* Inspection of the box and engine chocks ,
- \* Completing work on the engine chocks ,
- \* Adjusting bolts with torque wrench for precision. ,

The four chocks for the engine and two for the box were carried out by pouring Belzona 7111 which has American Bureau of Shipping certification. Once the product cured completely, it underwent compression with weight and adjustment of anchor bolts maintaining the specified parameters of alignment. It has been proven that Belzona 7111 has a lower cost than other chocking materials.
