BELZONA 7111 PROVIDES CHOCKING TO DRIVE SYSTEM ON FISHING BOAT

ID: 5933

Customer Location: Fishing Company, Peru

Application Date: September 2015

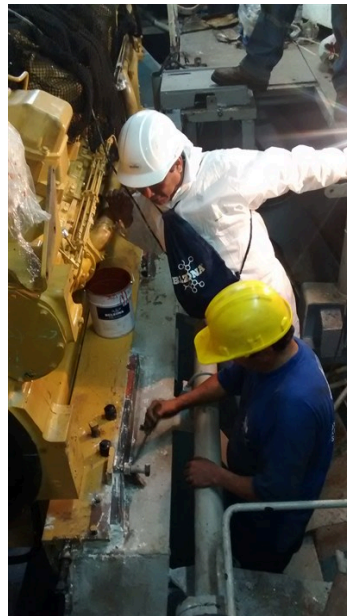
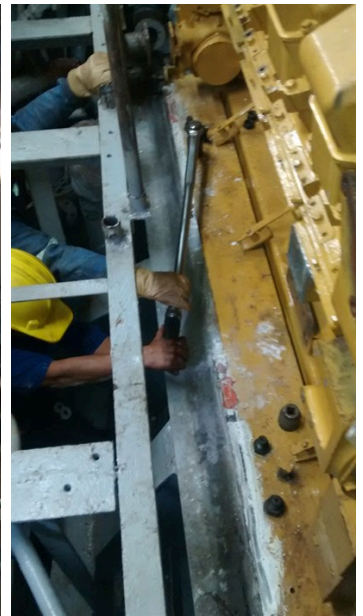
Photograph Descriptions

- * View of the engine and machine room ,
- * Inspection of the box and engine chocks ,
- * Completing work on the engine chocks ,
- * Adjusting bolts with torque wrench for precision. ,

The four chocks for the engine and two for the box were carried out by pouring Belzona 7111 which has American Bureau of Shipping certification. Once the product cured completely, it underwent compression with weight and adjustment of anchor bolts maintaining the specified parameters of alignment. It has been proven that Belzona 7111 has a lower cost than other chocking materials.
