MOORING WINCH BONDED TO DECK WITH BELZONA

ID: 5974

Customer Location: Flotel, Arendal, Norway
Application Date: May, 2011

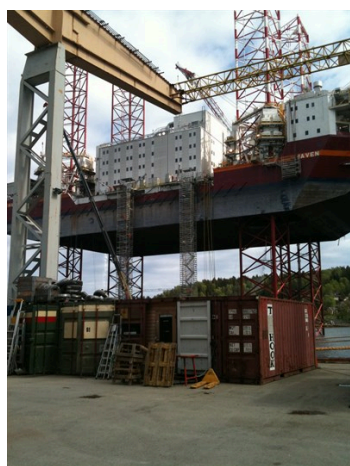
Due to issues with welding and passive fire protection installed on deck, an alternative solution was needed to bond a mooring winch to a deck structure.

- * View of the deck ,
- * Dry-fitting the winch ,
- * Bonding application using Belzona 1111 ,
- * Completed application ,
