# BELZONA SEALS FLANGE ON VACUUM DRYER

ID: 5986

**Customer Location:** Food Process, Girvan, Scotland  
**Application Date:** November 2015

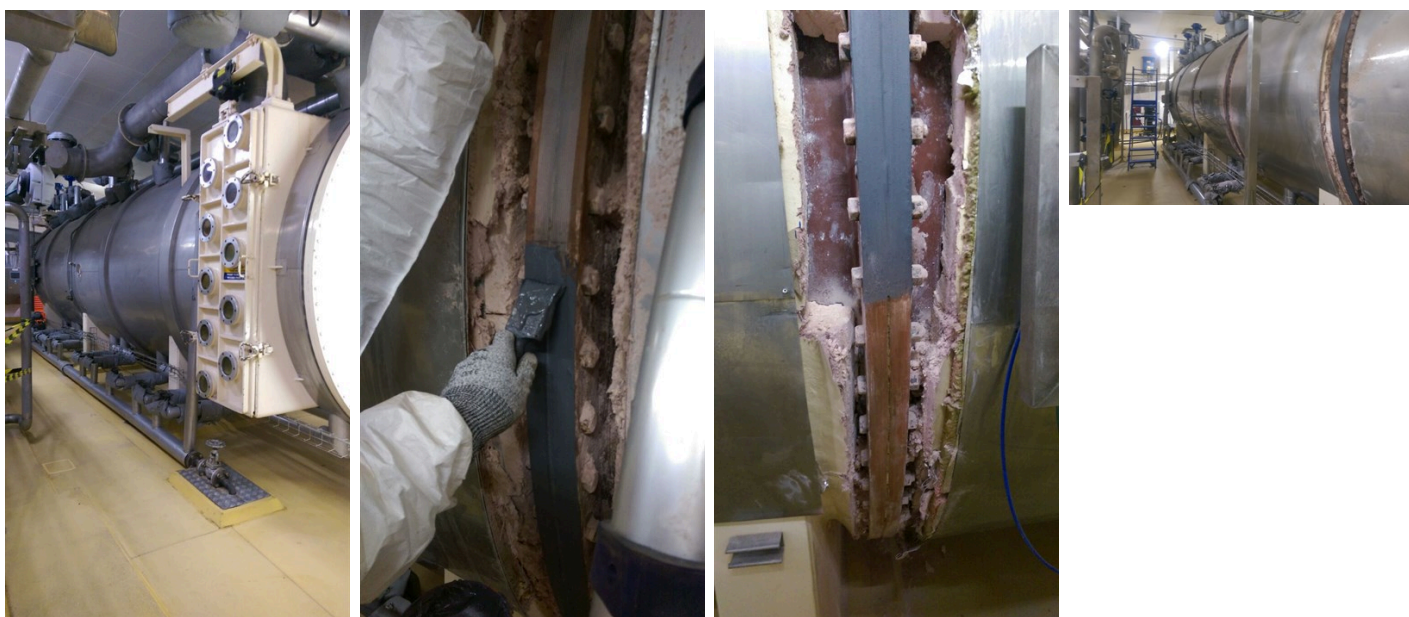
A leak around the flange had developed, preventing a vacuum to be accurately maintained within the vessel. This was affecting the drying process and production. A solution to seal this leak around the flange was required without dismantling the equipment. When the vessel is in operation it runs at elevated temperatures.

- \* Vacuum vessel ,
- \* 1st coat of Belzona 5851 applied with Belzona 9341 ,
- \* Application in progress ,
- \* Completed flange seal ,

A large diameter (approximately 2m) flange on vacuum drying vessel.

The application was carried out in accordance with Belzona Know-How System Leaflet VPF-11 while the vessel was running at temperature. The surface temperature was maintained at 90 to 110°C. After preparing the substrate, Belzona 5851 was applied as a 3 coat system in conjunction with Belzona 9341. By drawing a vacuum from within the vessel, the Belzona 5851 material was actually pulled into the void areas before curing off. This ensured all the leak areas were attended to and sealed.
