BELZONA PROVIDES NON-SLIP SURFACE TO TRANSFER ROLLER

ID: 5996

Application: *SHM-Solids Handling Machinery*

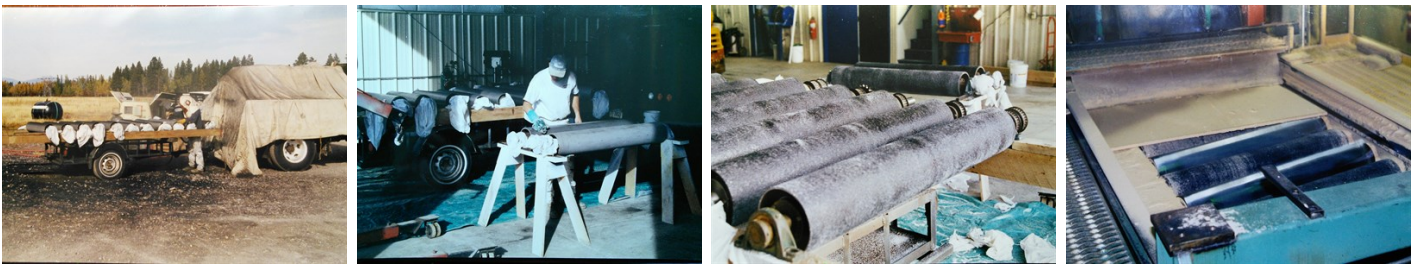
Photograph Descriptions

Transfer rollers that move boards downstream of platen press are smooth, causing lack of traction to keep line running.

- * Achieving a proper blast profile. ,
- * Belzona 9111 to clean and degrease before and after blasting. ,
- * Transfer rollers curing after coating and aggregate applied. ,
- * Transfer rollers installed and keeping the line going. ,

The application was carried out in accordance with the IFU for Belzona 5811. The coating was brush applied and the aggregate was spread by hand.
