RUDDER PINTLE REBUILT WITH BELZONA 1111

ID: 6004

Rudder pintle shaft on a 700' US Navy ship.

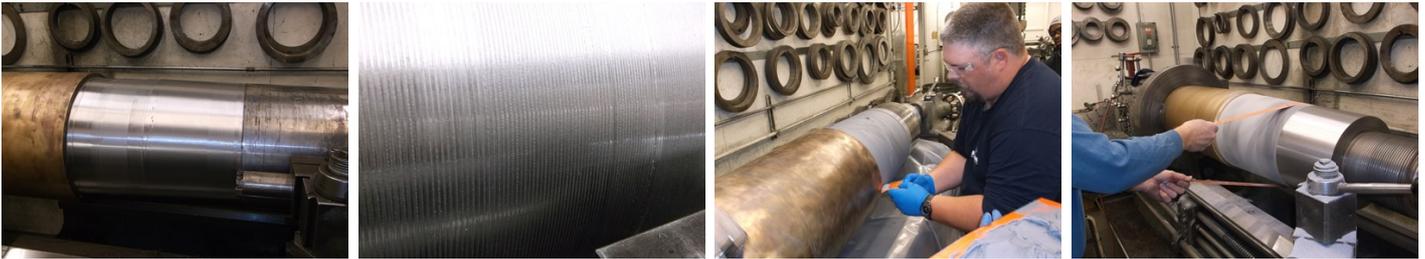
Shaft was corroded and pitted from salt water.

- * Shaft already machined down, some damage still visible. ,
- * Rough cut thread pattern. ,
- * Applying Belzona 1111. ,
- * Completed application, finishing with emery cloth. ,

All of the damaged areas were removed with a lathe. The surface was then prepared with the lathe to leave a super rough thread pattern to ensure a full mechanical bond. Again, using the lathe, Belzona 1111 was applied with a slow rotation. After a sufficient amount of material was applied, Belzona 1111 was allowed to fully cure and then machined to the required specifications. There was one low spot and a couple of air pockets visible, so those areas were once again abraded and a further layer of Belzona 1111 was applied and allowed to cure before the final machine cut was made. The final finish was made using emery cloth, leaving a perfect smooth finish.
