# BELZONA STATIC DISSIPATIVE LINING FOR CHEMICALLY AGGRESSIVE ENVIRONMENT

Industry: Chemical & Petrochemical  
Application: TCC-Tanks and Chemical Containment Areas

Customer Location: Refinery, France

Substrate: Carbon Steel

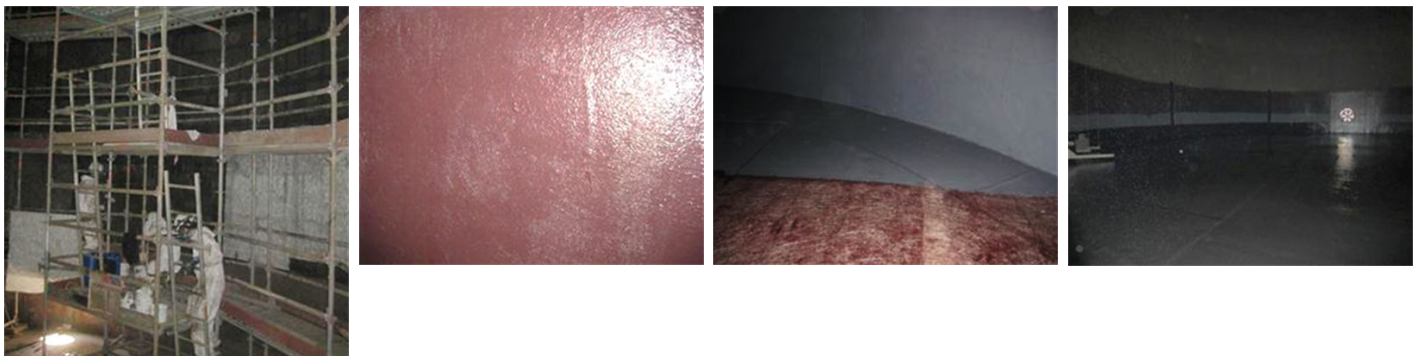
\* 1. Scaffolding assists Belzona 4311 application <br /> 2. First layer of Belzona 4311 applied <br /> 3. Application of the lining on the floor <br /> 4. Application of Belzona 4351 completed ,  
<ul>  
</ul>

The application was carried out in accordance with Belzona Know-How System Leaflet TCC-5. After thorough surface preparation, a two layer system of Belzona 4311 was applied throughout the tank. Finally, across the tank's entire bottom and half a metre up the walls, the application was finished with a coat of Belzona 4351. Note that Belzona 4351 was sufficiently grounded.

Scaffolding was installed allowing for safe and effective application even at the full height of the tank. This solution reduced downtime, meaning the tank could be put into service in a very short time. Belzona system provided the required level of acid resistance combined with the need for static dissipation.
