BELZONA STATIC DISSIPATIVE SOLUTION APPLIED TO SILO

ID: 6017

Customer Location: Bio-fuel Producer, Mannheim, Germany
Application Date: November 2011 - February 2012

Substrate: Concrete and Steel
Products: * Belzona 4111 (Magma-Quartz),
* Belzona 4351 (Magma CR5),

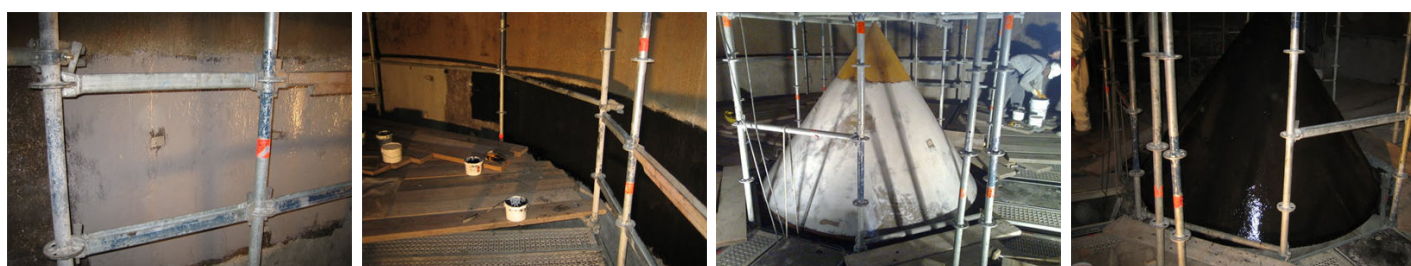
Photograph Descriptions

Some of the internal walls and steel cones needed repairing. In addition, a static dissipative coating was required to protect against static build up within the silo.

- * Earthing points left exposed in restored silo wall ,
- * Section of silo coated in Belzona 4351 ,
- * Silo cone repaired and left with earthing points ,
- * Silo cone coated with Belzona 4351 ,

Application was carried out in accordance with Belzona Know-How System Leaflets TCC-3. Damaged concrete was repaired with Belzona 4111. Belzona 4351 was applied to walls and cone taking care to ensure Belzona 4351 was in direct contact with the earthing points provided.
