UNDETECTABLE MOISTURE BARRIER FOR MUSEUM PROVIDED WITH BELZONA

ID: 6035

Customer Location: Historic Museum, Teesside, UK
 Application Date: 2010

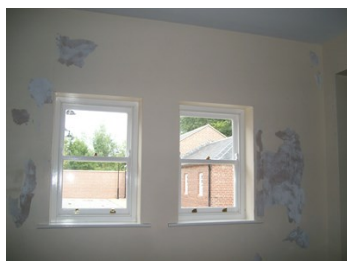
On the external walls of the East Lodge building, it was found that moisture ingress from driving rain quickly destroyed the newly refurbished rooms, wasting a large portion of the budget. A cost effective weather proofing solution that would not affect the appearance of the buildings was required.

- * Museum situated within Historic Estate ,
- * Damage to paint and plasterwork in classroom ,
- * Original application completed in 2010 ,
- * East Lodge revisited in 2016 ,

of saturated walls by up to 40%. Approximately 270 square meters of the external walls were quickly treated with a simple application that minimised disruption to the museum visitors. The surface was immediately weatherproof and undetectable to the naked eye. The client was delighted with the results and the refurbishment to the rooms within could resume without further risk. The protection of the building was reassessed 6 years later and found to still be working perfectly.
