# LOCALIZED BELZONA REPAIRS TO RUBBER LININGS

ID: 6060

**Industry:** Power  
**Application:** TCC-Tanks and Chemical Containment Areas  
**Substrate:** Carbon steel with 6mm neoprene rubber lining.  
**Products:** \* Belzona 2111 (D & A Hi-Build Elastomer) ,  
\* Belzona 2911 (Elastomer QD Conditioner) ,

**Customer Location:** Power Plant, UK  
**Application Date:** 2007

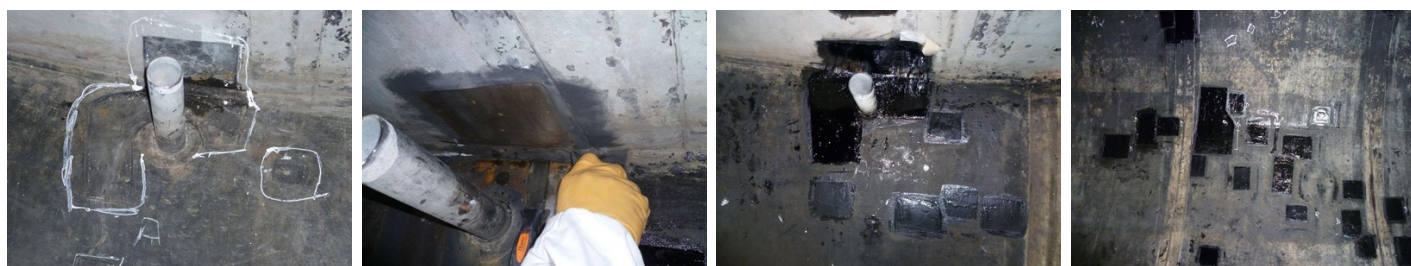
The client had recurring failures of the aged neoprene rubber linings on the site. Reinstatement or repairs with the original lining materials were impossible due to unacceptable downtime and health & safety concerns. A localised repair solution was needed that could be easily applied in confined spaces to complex surfaces, and would allow a fast return to service.

- \* Defect areas marked up in a water treatment tank ,
- \* Failed neoprene rubber lining being removed ,
- \* Completed repairs with Belzona 2111 ,
- \* Further repairs completed on tank walls ,

Application was carried out in accordance with Belzona Know-How System Leaflet TCC-3. After preparing the substrate, Belzona 2911 was applied before repairing the rubber lining with Belzona 2111.

Belzona 2111 is a solvent free, liquid applied elastomer and can be applied at depths of up to 12mm on a vertical surface, which allows the repairs to be completed in a single application.
