# BELZONA TERMINATES ATTACK FROM CHILLER TREATMENT CHEMICALS

ID: 6073

**Industry:** General Industry  
**Application:** TCC-Tanks and Chemical Containment Areas  
**Substrate:** Carbon Steel and Galvanized Steel  
**Products:** \* Belzona 5811 (Immersion Grade),

**Customer Location:** Pharmaceutical Plant, UK  
**Application Date:** 2014

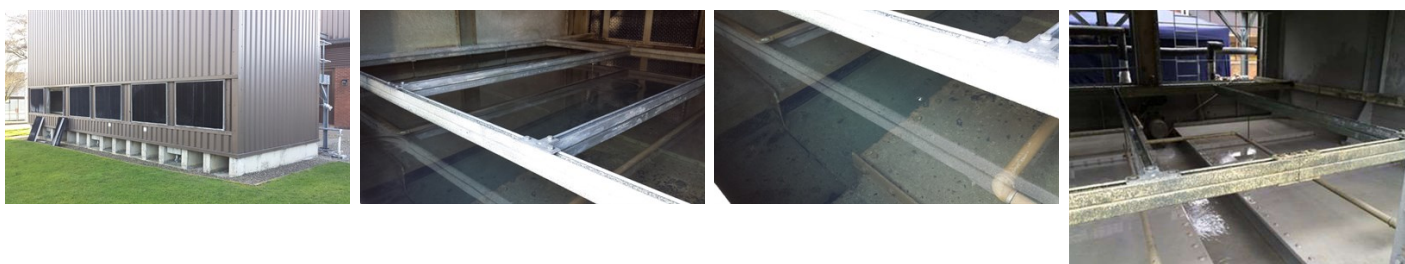
*The galvanised steel and carbon steel surfaces of these tanks were being attacked by the chemicals that were being used to keep Legionnaires' disease in check and from corrosion. It was understood that without action, the tanks would start to leak and so all six tanks were to be coated in phases.*

- \* Chiller units ,
- \* Lower tanks during initial inspection in 2014 ,
- \* Condition of tanks close-up before coating ,
- \* Tanks protected with Belzona 5811 in 2014 ,

Lower tanks of chiller units suffering attack from Legionella treatment chemicals.

Application was carried out in accordance with Belzona Know-How System Leaflet TCC-5. After grit blasting the surfaces, Belzona 5811 was applied by brush in two coats. Only two tanks at a time could be shut down, so the six tanks were coated in phases.
