BELZONA REPAIRS CONCRETE ROAD IN CHEMICAL PLANT

ID: 6091

Customer Location: Chemical Plant, Teesside, UK
 Application Date: 2010

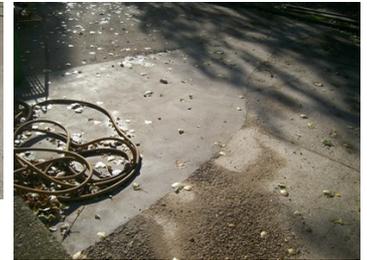
The roads on site had suffered attack from chemicals and regular heavy lorry traffic had cracked and eroded the concrete in many areas around the plant, including access roads. Repairs had been completed several times previously with cementitious materials. These had, however, never survived for long and once again the uneven surfaces had become hazardous for vehicles and foot traffic alike.

- * Typical damage on roads around site ,
- * Cracks filled and area resurfaced ,
- * Further repairs completed in main road ,
- * Repair revisited after 5 years ,

The Belzona solvent free concrete repairs offered a long lasting solution with a proven track record. Due to the extent of repairs required, Belzona 4131 was chosen as the most cost effective solution. For deep damage, Belzona 4131 was bulk filled 50/50 with 6mm pea gravel and resin before topping with Belzona 4131. The repairs were revisited after 5 years and there was only minor

cracking in the heaviest traffic areas where it was known that there were still loose slabs.
