# BELZONA SEALS REMOTE PUMP HOUSE FLOORS

Application: FPA-Floor Problem Areas

Substrate: Concrete Floor with Steel Trims

Customer Location: Water Company, Teesside, UK

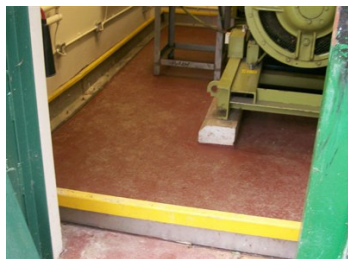
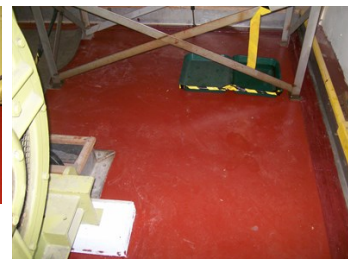
The client had a series of remote pump houses with diesel storage tanks inside and these facilities were seldom visited. Should there be a leak of diesel, it could be weeks before it was discovered and it was known that the floors would not hold fluids reliably. Previously the floors have been coated with a conventional solvent based paint and angled edging trims had been fixed to the floor to try and create a containment area. Both of which had failed.

- \* One of the remote pump houses ,
- \* Existing floor during initial inspection ,
- \* Belzona 2121 being applied to seal the edging trim ,
- \* Application completed in 2011 ,

Application was carried out in accordance with Belzona Know-How System Leaflets FPA-3 and FPA-7. Following surface preparation, 2 coats of Belzona 5231 were applied to the concrete floor. The joint between the steel edging trim and the floor was then sealed by applying a narrow band of Belzona 2121, reinforced with Belzona 9341.
