# CAST IRON BELZONA GRIP ON COAST

Application: FPA-Floor Problem Areas

Customer Location: Port Authority, Teesside, UK

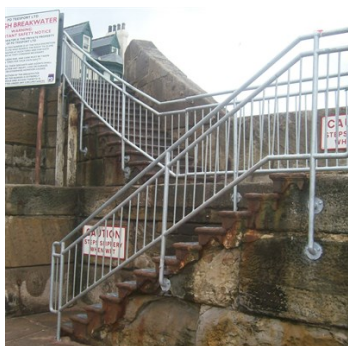
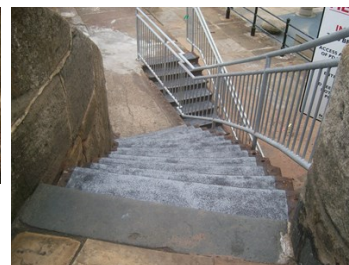
*These steps had been worn down after decades of use from the public. The polished surfaces were slippery even when dry, and in wet conditions they were treacherous. These steps led to a very popular breakwater and beach, and so access through the day could not be restricted. In addition, there was about to be a major "Big Ships" event, and thousands of visitors were expected to be using these steps. With "Slips & Trips" being the main source of reported injuries in the UK, the client was very conscious of the risks to the public.*

- \* 25 steps to the breakwater and beach ,
- \* Cast iron worn smooth ,
- \* Same steps after application ,
- \* Completed application ,

Application was carried out in accordance with Belzona Know-How System Leaflet FPA-8.

quickly and after an overnight cure the area was reopened to the public. Not a single slip was reported during the popular maritime event which followed. In addition, the Belzona solution continues to offer protection from erosion and corrosion in one of the most exposed area of this coastline.
