# BELZONA SEAMLESS ROOFING FOR SUBSTATIONS

ID: 6109

Customer Location: Refinery, UK  
Application Date: 2009

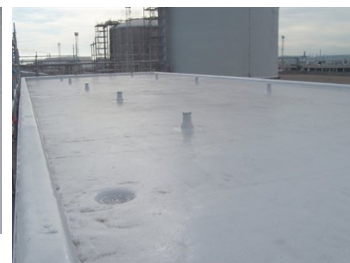
- \* Substation flat roof ,
- \* Asphalt de-chipped ,
- \* New vent detail of finished system ,
- \* Completed roof fully protected with Belzona 3131 ,

Flat asphalt roofs over plant electrical substations. The roof illustrated here was the first of many refurbished on site and comprised 18mm chippings over an asphalt deck totalling 260 square meters with extensive lichen and moss growth.

Application was carried out in accordance with Belzona Know-How System Leaflets RPA-1, RPA-2, RPA-6, RPA-8, RPA-10 and RPA-11 to address the many different situations.

high voltage electrical equipment. The roof was fully reinforced to create a completely seamless membrane that offers over 20 years durability. The Winter Grade system proved to be a real advantage whilst applying the materials during the typically wet UK weather. During 2009, 14 substation roofs totalling over 2200 square meters were protected with applications continuing throughout the winter months.
