# BELZONA COLD APPLIED ROOFING FOR SUBSTATION

ID: 6110

Customer Location: Refinery, UK  
Application Date: 2009

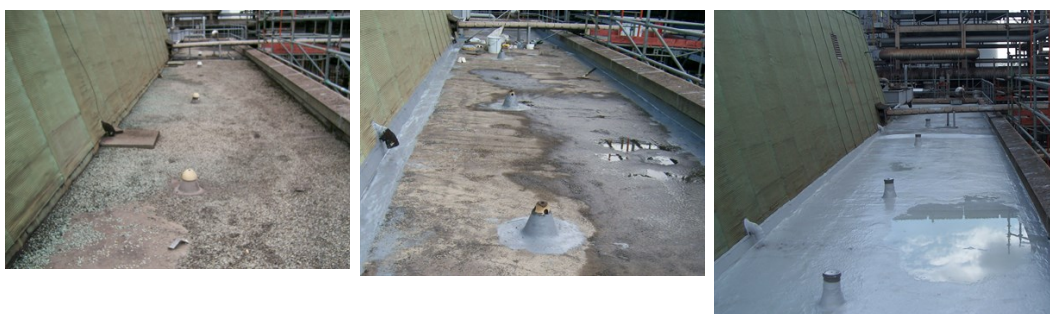
## Photograph Descriptions

The client had a series of aged asphalt roofs around the facilities that were leaking. On this Substation there was also a copper clad plant room that was leaking around the edges. Renewing the asphalt would have been impossible due to the complexity of the roof and any hot works on the site was prohibited.

- \* Substation flat roof ,
- \* Asphalt de-chipped and application started ,
- \* Completed roof protected with Belzona 3131 ,

Substation flat asphalt roof and plant room waterproofing.

Application was carried out in accordance with Belzona Know-How System Leaflets RPA-02, RPA-06, RPA-08, RPA-10, RPA-11 to address the different situations.

The Belzona 3131 system is a cold applied liquid solution that provides a seamless membrane across the complete roof, no matter how detailed. A further benefit is that the Belzona 3131 has very good adhesion directly to the asphalt, which reduces the number of coats required and the overall contract costs. The reinforced system is very durable providing a long service life. The client was
