# CHECKER PLATE ROOF JOINTS SEALED WITH BELZONA

Industry: Chemical & Petrochemical  
Application: RPA-Roof Problem Areas  
Substrate: Checker plate steel panels.  
Products: \* Belzona 3121 (MR7) ,

Customer Location: Petrochemical Plant, UK  
Application Date: 2009

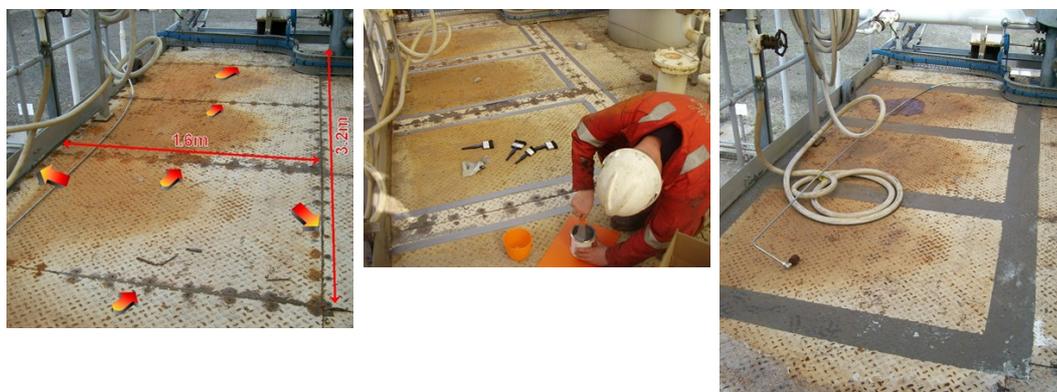
## Photograph Descriptions

The checker plate panels were landed on a gasket seal. Unfortunately, the seals for several panels had failed and water was penetrating into the asset. A bigger problem was presented by caustic vapours escaping from the joints during certain production phases. With no planned shutdown imminent, the client was urgently seeking a solution that could be rapidly installed. The site had many flammable materials and so only cold works and minimal preparation would be allowed.

- \* Heater roof with failing joints identified ,
- \* Belzona 3121 being mixed before application to the prepared joints ,
- \* Final application revisited after 1 year ,

Application was carried out in accordance with Belzona Know-How System Leaflet RPA-1.

Belzona 3121 is a liquid applied emergency roofing material that bonds directly to most substrates. This allows for a very quick application and so minimal downtime was required for this work. In addition, the materials are immediately weatherproof. Whilst

the application was originally only intended to be a short term solution, it sealed the panels perfectly for over 2 years until the client finally scheduled the replacement of the seals beneath the roof panels.
