TEMPERATURE REDUCED ON METAL ROOF WITH BELZONA

Application: RPA-Roof Problem Areas

Substrate: Sectional steel roofing.

Customer Location: Hospital, Teesside, UK

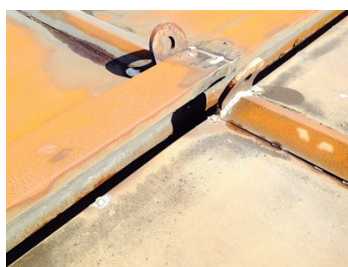
Leaks were evident from the jointing trims on the roof and the very narrow gutters. An additional problem during the summer months was the high internal temperatures of the rooms beneath and air-conditioning units would struggle to keep the areas cool enough for the staff and supplies. In fact, the building was known locally to staff as the "biscuit tin", as you would bake inside it.

- * Corroded sectional metal roof ,
- * Gutter detail close up ,
- * Gutter detail coated with Belzona 3111 ,
- * Completed application ,

The application was carried out in accordance with Belzona Know-How System Leaflets RPA-1, RPA-6 and RPA-8.

The Belzona 3111 water based membrane was able to seal the most complex of geometries with a simple brush application. Despite the gutters being only 70mm wide and having restricted access, they were all successfully sealed. The whole roof was protected with Belzona 3111 in a light grey colour to help with solar reflection in the summer, and so help reduce the temperatures inside.
