# TEMPERATURE REDUCED ON METAL ROOF WITH BELZONA

ID: 6114

Customer Location: Hospital, Teesside, UK  
Application Date: 2014

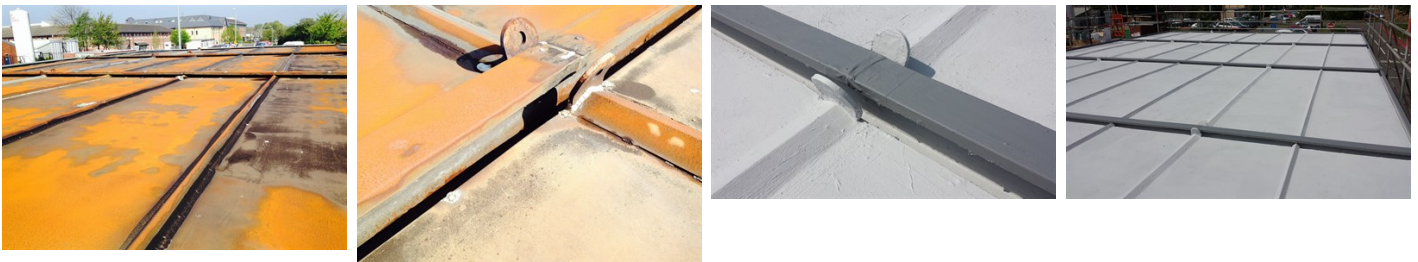
## Photograph Descriptions

Leaks were evident from the jointing trims on the roof and the very narrow gutters. An additional problem during the summer months was the high internal temperatures of the rooms beneath and air-conditioning units would struggle to keep the areas cool enough for the staff and supplies. In fact, the building was known locally to staff as the "biscuit tin", as you would bake inside it.

- \* Corroded sectional metal roof ,
- \* Gutter detail close up ,
- \* Gutter detail coated with Belzona 3111 ,
- \* Completed application ,

The application was carried out in accordance with Belzona Know-How System Leaflets RPA-1, RPA-6 and RPA-8.

The Belzona 3111 water based membrane was able to seal the most complex of geometries with a simple brush application. Despite the gutters being only 70mm wide and having restricted access, they were all successfully sealed. The whole roof was protected with Belzona 3111 in a light grey colour to help with solar reflection in the summer, and so help reduce the temperatures inside.
