BELZONA REJUVINATES AGED ASPHALT ROOF

ID: 6117

Customer Location: Power Station, Teesside, UK
Application Date: 2016

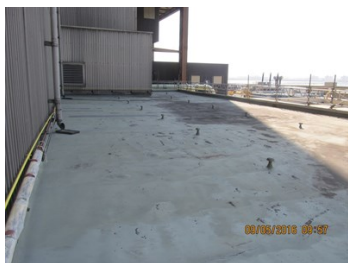
This aged asphalt roof was cracked in many places and there were several large ponding areas where water would not fall to drains. A much larger pitched roof above it also drained directly onto the asphalt, resulting the roof having to accommodate about six times more water than it was designed for. These problems had led to several leaks being identified in the plant rooms beneath and essential equipment was at risk of being ruined. Environmental and safety considerations mean the client preferred a water based system.

- * Roof with ponding areas on right ,
- * Application of Belzona 3111 underway ,
- * Protection completed ,
