BELZONA CREATES NON-SLIP SAFETY SURFACE IN FISH MARKET

ID: 6148

Application: FPA-Floor Problem Areas

Customer Location: Fish market, Croatia

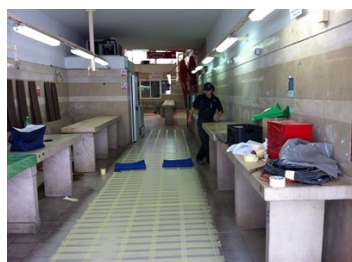
Existing quarry tiles are wet and slippery. During summer season there is plenty of people and there was a risk of slipping and injuries. Customer was looking for solution that could solve the slipping problem without the need to close the market.

* 1. Situation in the fish market, positioning of masking tape 2. Surface preparation. 3. Application of Belzona 5231 with additional aggregate incorporated. 4. Application completed - situation after washing the floor ,
