BELZONA PROVIDES HYGIENIC WALLS

ID: 6285

Application: WPA-Wall Problem Areas

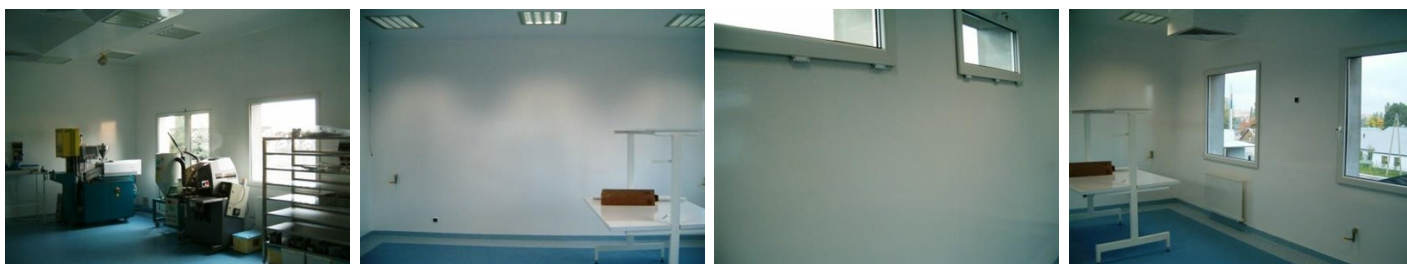
Photograph Descriptions

The previous coating on the walls did not withstand ultraviolet radiation, and liquid disinfectants used to create a sterile environment.

* 1. The room under renovation 2.,3.,4. The walls coated with Belzona 5111 ,

The high gloss Belzona 5111 resists the germicidal lamps and liquid disinfectant used to create a sterile environment. Belzona 5111 is ideal for creating hygienic wall surfaces.
