BELZONA USED ON FERRY WATER JET

ID: 630

Ferry water jet propulsion units

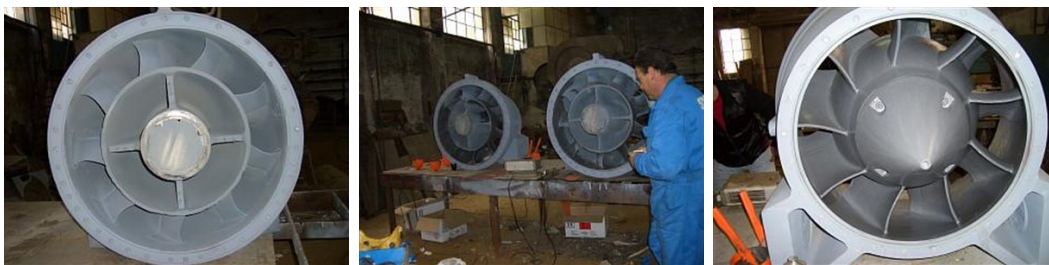
Photograph Descriptions

Units had significant erosion-corrosion.

- * Unit before coating ,
- * Application of Belzona ,
- * Finished application ,

Substrate: *Aluminium*
Products: ** Belzona® 1111 (Super Metal) ,*
** Belzona® 1321 (Ceramic S-Metal) ,*

Application carried out in accordance with Belzona Know-How System Leaflets FBC-1 and FBC-2.
