# Belzona Reseats Rudder to a Rudder Stock

ID: 6319

Industry: Marine  
Application: SOS-Ships and Offshore Structures

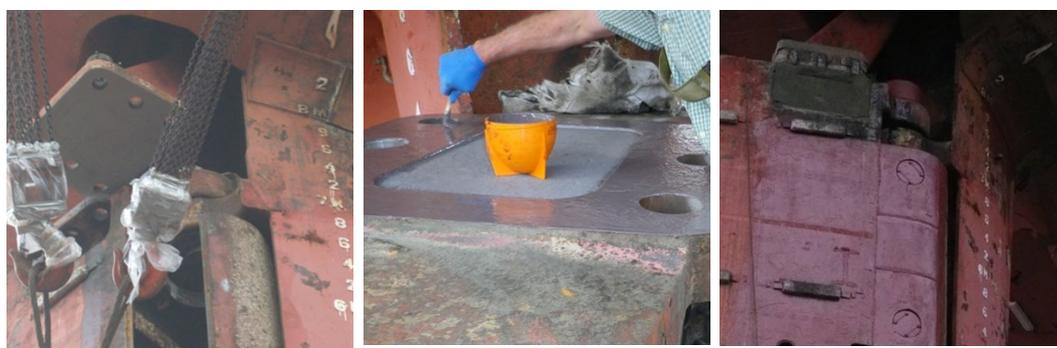
Corrosion had developed between the two mating surfaces that made it impossible to effectively seal against sea water penetration. The alternate method of repair would be machining both surfaces which would have been impossible under these dry docking conditions.

- \* The corroded surface of the rudder after grit blasting. ,
- \* The repair area coated with Belzona 1321. ,
- \* The completed application. ,

The application was carried out in accordance with a modified version of Belzona Know-How System Leaflet SOS-8. The corroded surface of the rudder was grit blasted to a near white metal finish. While the other surface was cleaned and coated with Belzona 9411. The grit blasted surface was given a full coat of Belzona 1321 and allowed to firm up for approximately 2 hours before it was bolted into position.
