BELZONA PROVIDES FOOD FOR THOUGHT

Customer Location: Food Processing Plant, Manchester UK

Application: VPF-Valves, Pipes and Fittings

Large exhaust duct bend

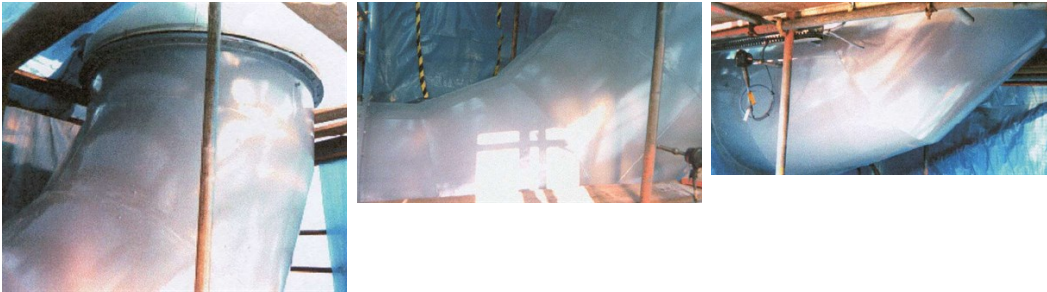
Photograph Descriptions

Several holes in the weld seams and isolated pinholes. All surfaces showed signs of corrosion and existing paint work was cracked and peeling.

- * Exhaust duct outlet ,
- * Exhaust duct bend ,
- * Exhaust duct repaired ,

Application was carried out in accordance with Belzona Know-How System Leaflets VPF-1 and VPF-2.

This system was selected to provide long term protection in the wet and polluted atmospheric conditions. This was coupled with its excellent appearance. The application is still performing well after six years.
