# Belzona Delivers Accuracy to a Weigh Scale Platform

ID: 6320

Customer Location: British Columbia, Canada  
Application Date: August 2011

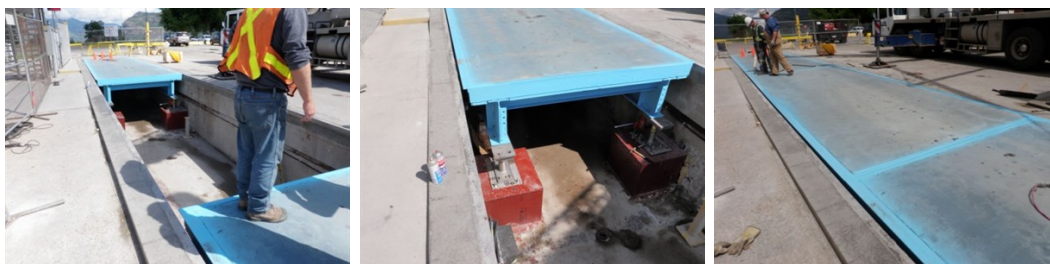
*The scale consists of three separate sections bolted together; the machined surfaces where the sections connect were corroded and could no longer provide the solid connection required for accuracy.*

- \* The mating surfaces between sections of the weigh scale platform were badly pitted. ,
- \* The center section of the scale had to be lowered into this gap with only 1/4 inches of clearance either end. ,
- \* The center section was in place and bolted to the ends with Belzona 1121. ,

The application was carried out in accordance with a modified version of Belzona Know-How System Leaflet GSS-4. The mating surfaces between sections of the weigh scale platform were badly pitted. They were originally coated with a blue paint, which was removed prior to application. The center section of the scale had to be lowered into this gap with only 1/4" of clearance on either end. The center section was in place and bolted to the ends with Belzona 1121 providing a positive contact between the mating surfaces to ensure accuracy.

The corroded surfaces were prepared, then Belzona 1121 was applied between the connectors, prior to bolting to fill any voids caused by corrosion and provided full contact irregular shim between the surfaces. The extended set up time of Belzona 1121 allowed the delicate assembly to proceed without haste.
