Belzona Coats Submersible Pump for Potable Water

Customer Location: Filtration Plant, Montréal, Québec, Canada

Application: CEP-Centrifugal Pumps

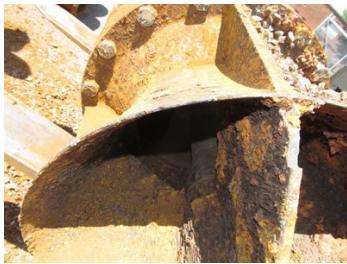
Photograph Descriptions

After several years in use this pump needed to be repaired and protected due to erosion/corrosion. Being a filtration plant a product with NSF 61 approval was specified by customer.

* 1. Suction bell before 2. Suction bell blasted to specs and rebuilt with Belzona 1111 3. Suction bell with 5812DW 4. Other pump parts coated inside out with 5812DW ,

Belzona surface preparation respected. 3 mils roughness profile. Aluminium oxide angular abrasive was used for blasting. Belzona system leaflets, CEP-3, 4, 6, was followed.
