BELZONA PROVIDES ABRASION RESISTANT PROTECTION FOR SCREW CONVEYOR

ID: 6349

Industry: Water / Wastewater
Application: SHM-Solids Handling Machinery

Customer Location: Waste water treatment plant, Romania
Application Date: May 2013

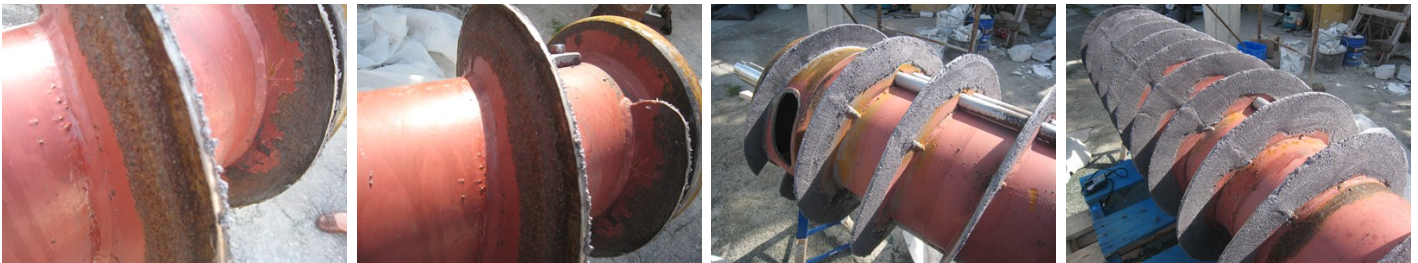
Photograph Descriptions

As part of its operation in a treatment plant's slurry clarifier, the screw conveyor was transporting dehydrated slurries. The hard particles in the slurry were causing abrasion of the conveyor blades.

* 1. Screw conveyor affected by erosion corrosion 2. Metal loss on the blades 3. Belzona 1812 applied 4. Equipment life extended with Belzona protection ,

The screw conveyor at a water treatment plant was suffering from significant metal loss.

Application was carried out in accordance with Belzona System Leaflet SHM-14. After gritblasting Belzona 1812 was applied to the blades to provide abrasion resistant protection.

Belzona 1812 (Ceramic Carbide FP) offers resistance to abrasive wear, significantly extending the life of the screw conveyor.
