BELZONA COLD PLATE BONDING REINFORCES OFFSHORE DECK

ID: 6372

Customer Location: Gulf of Mexico, USA

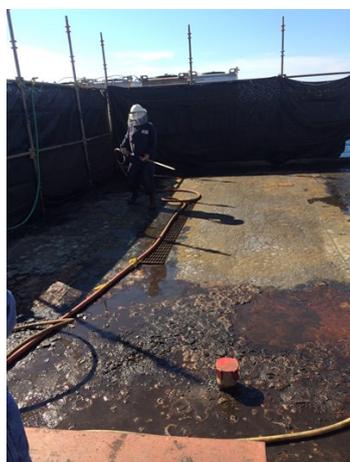
The customer had an integrity inspection performed on their steel decks as part of a life extension program. Several areas on two decks were noted to have thicknesses below the minimal thickness allowed. Some areas had holes which meant a loss of containment if there were an accidental spill.

- * 1. Pitted and corroded deck. ,
- * 2. Preparing deck and repair plate with border of Belzona 1121 ,
- * 3. Injecting Belzona 5811 (Immersion Grade) between repair plate and deck. ,
- * 4. Completed application. ,

Offshore platform had deck areas with 60% metal wall loss
