# BELZONA 1593 LINING PROTECTION OF LIQUID-LIQUID HYDROCYCLONE

ID: 6391

**Customer Location:** Oil & Gas Asset Owner, China  
**Application Date:** July 2016

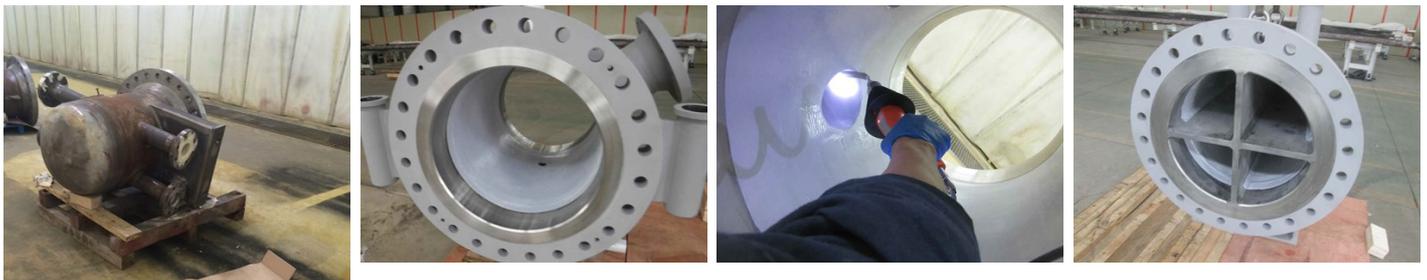
## Photograph Descriptions

- \* 1.Before Grit Blasting ,
- \* 2.Application of the 2nd coat of Belzona1593 in light grey ,
- \* 3.HVT Testing ,
- \* 4.Completed Application ,

Application was carried out in accordance with Belzona Know-How System Leaflet TCC-5 for protecting steelwork. After grit blasting to achieve Sa2.5 (SSPC-SP10) , Belzona 1511 was used to smoothen the welding areas with poor finish and a two-coat system of Belzona 1593 was brush-applied to the vessel surface.
